**PHIL'S DRAINAGE  
SERVICES LTD.**

Commercial Property, Fleet

**Blocked ground floor WC**

**Tuesday, 4 August 2026**

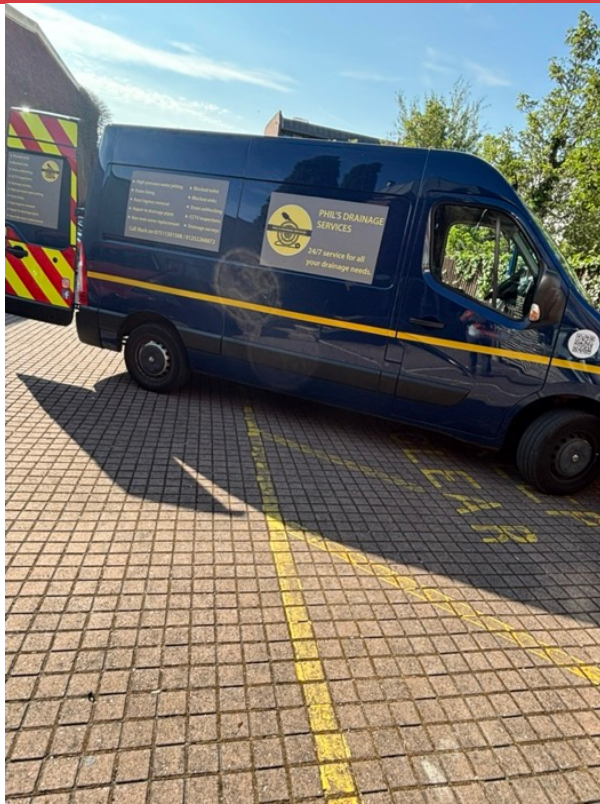
**1**

Assigned To Attended The premises Due To A Report Of A Ground Floor Wc Blockage  
Attended The premises Due To A Report Of A Ground Floor Wc Blockage

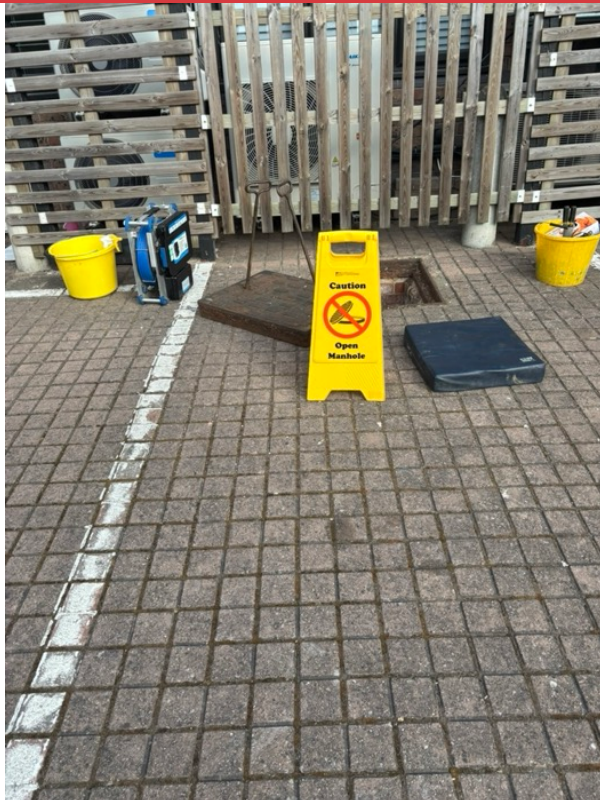
**2**

Assigned To Set Up Safety Signage And Barriers  
Located the external foul water chambers and proceeded to Set Up Safety Signage And Barriers

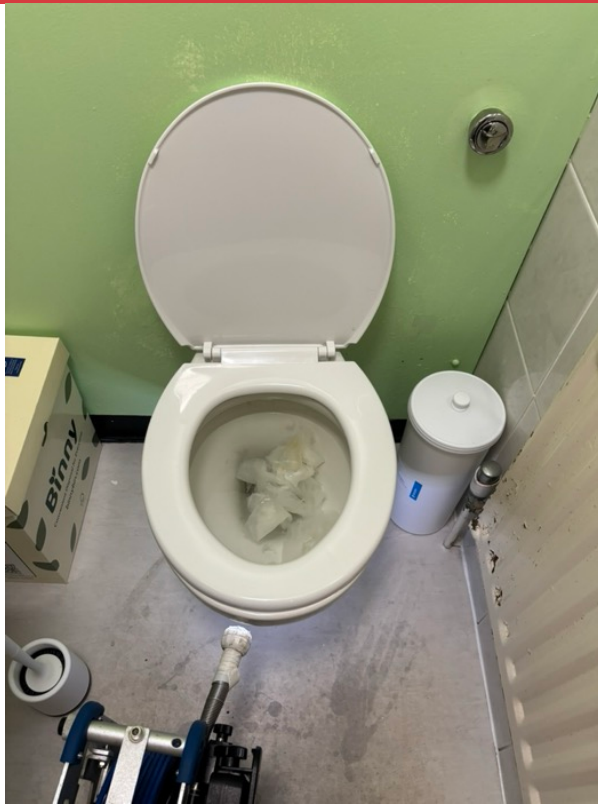
**3**

Ground Floor Left Wc Blocked On  
Arrival

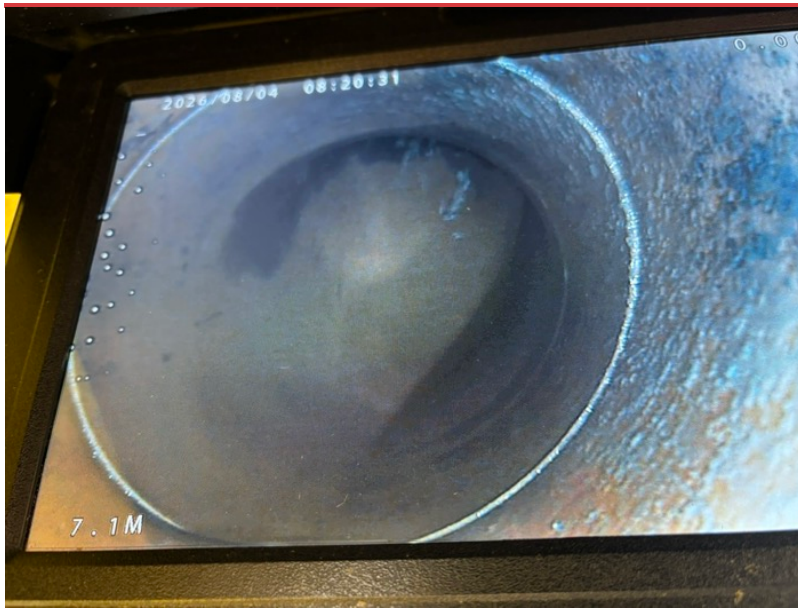
**9**

Arrived at below ground rest bend

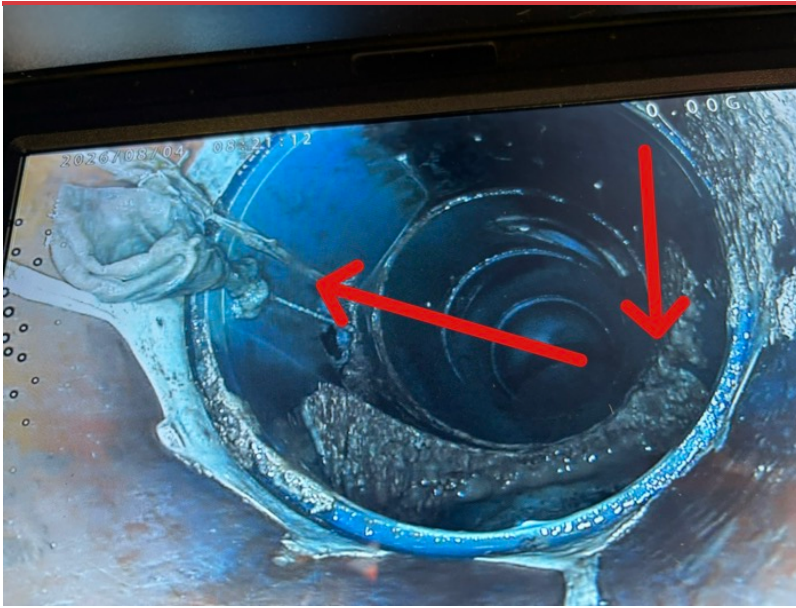
**10**

Arrived at internal vertical 100mm  
plumbing stack

\*\*\*\*\* located object and mass Uric  
scale urinal deposits \*\*\*\*\*

To accurately diagnose the cause of the blockage, a CCTV drainage survey was undertaken from the external inspection chamber upstream towards the internal 100mm foul water stack serving the ground floor WC facilities. The CCTV inspection identified extensive uric scale deposits attached to the internal walls of the vertical 100mm foul water stack

associated with the urinal discharge. These hard mineral deposits had significantly reduced the internal bore of the pipework and created a point where debris could accumulate. During the inspection, a plastic toilet freshener was also found lodged within the affected section of pipework, contributing to the restriction. Beyond this area, the remaining pipework was found to be free flowing.

a full mechanical descale of both the internal and external 100mm foul water drainage serving the urinal facilities.

A full descale using specialist electromechanical cleaning equipment with appropriate chain flails is recommended to remove the attached uric scale back to the original pipe wall wherever practicable, restoring the maximum internal bore and reducing the risk of future blockages.

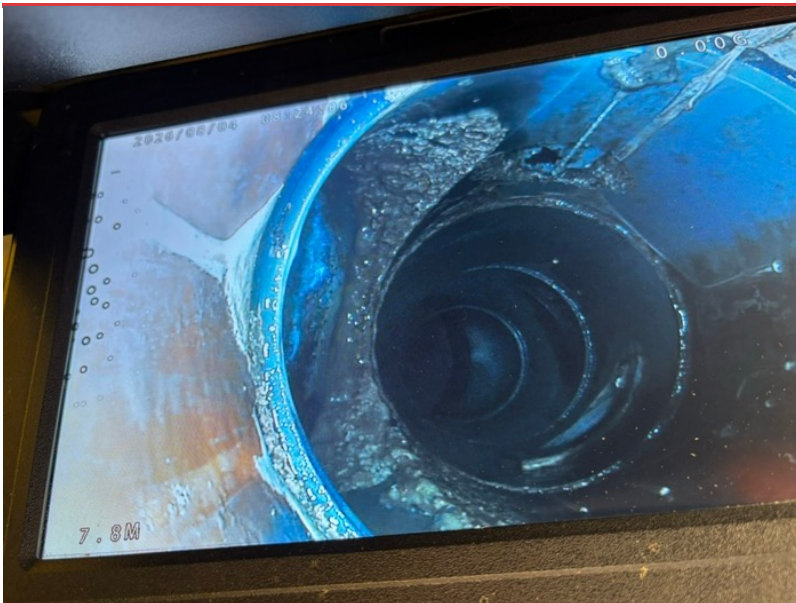
**11**

Arrived at internal vertical 100mm  
plumbing stack

\*\*\*\*\* located object and mass Uric  
scale urinal deposits \*\*\*\*\*

The CCTV inspection identified substantial attached uric scale deposits throughout sections of the pipework. Although the immediate blockage has been removed, these hardened deposits remain adhered to the pipe walls and will continue to:

- \* Restrict the internal diameter of the drainage system.
- \* Encourage the accumulation of paper, debris and waste.
- \* Increase the likelihood of recurring blockages.
- \* Reduce the hydraulic efficiency of the foul water drainage system.
- \* Create odour retention within the drainage network.

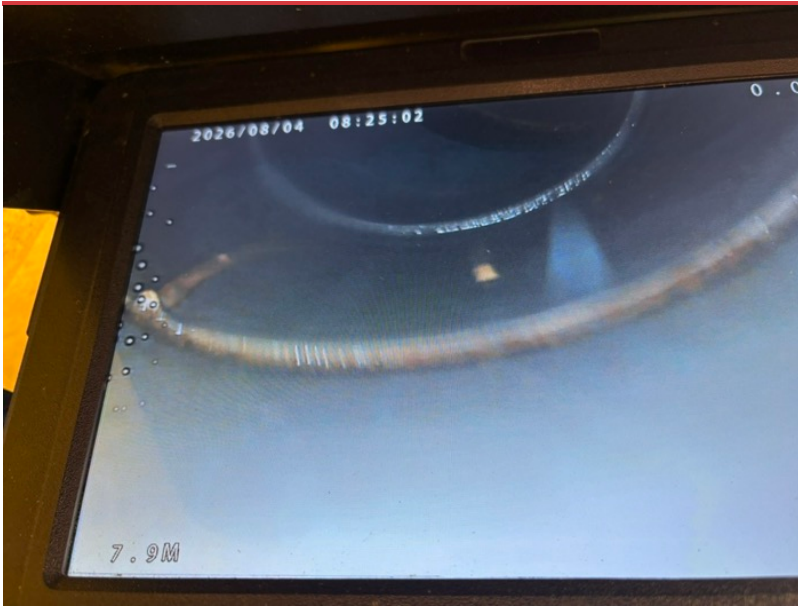
**12**

Assigned To Pipework Clear  
Beyond  
Pipework Clear Beyond

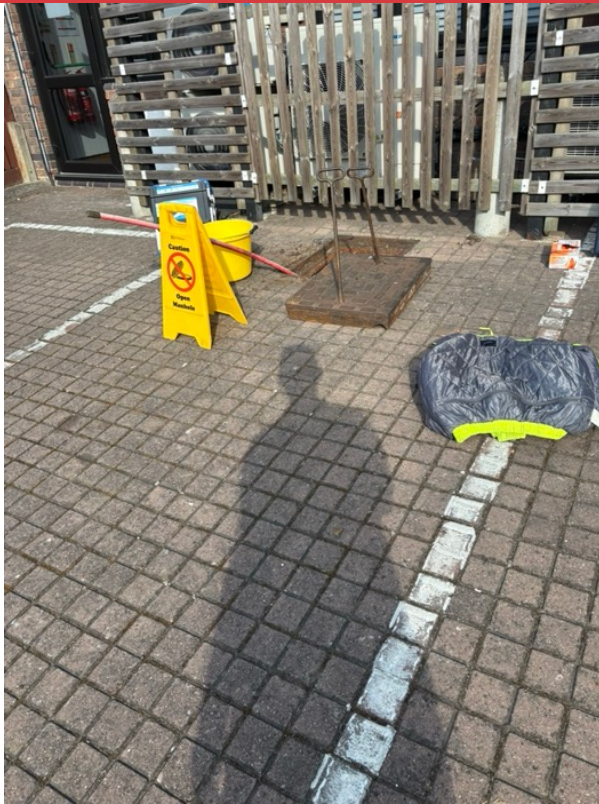
**13**

Assigned To Removing Obstruction  
Removing Obstruction

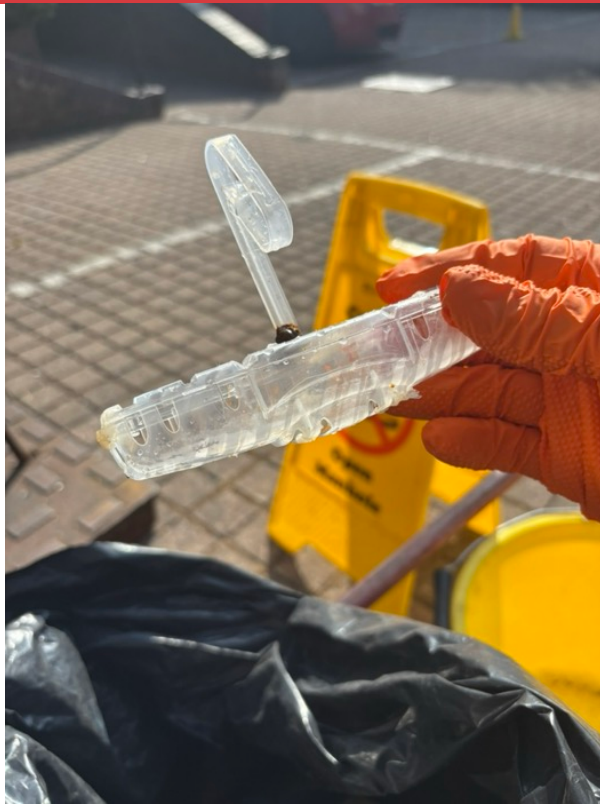
**14**

Assigned To Removing Obstruction  
Found To Be A Toilet Freshener  
Removing Obstruction Found To  
Be A Toilet Freshener

These products can become detached during use or flushing and enter the drainage system, where they are capable of becoming trapped within bends, uric scale deposits or changes in direction. This significantly increases the likelihood of drainage blockages and unnecessary disruption.

discontinuing the use of plastic clip-on toilet fresheners within the WC facilities.

Where possible, alternative non-plastic cleaning and deodorising products that do not introduce solid objects into the drainage system should be used as part of the site's ongoing washroom maintenance programme.

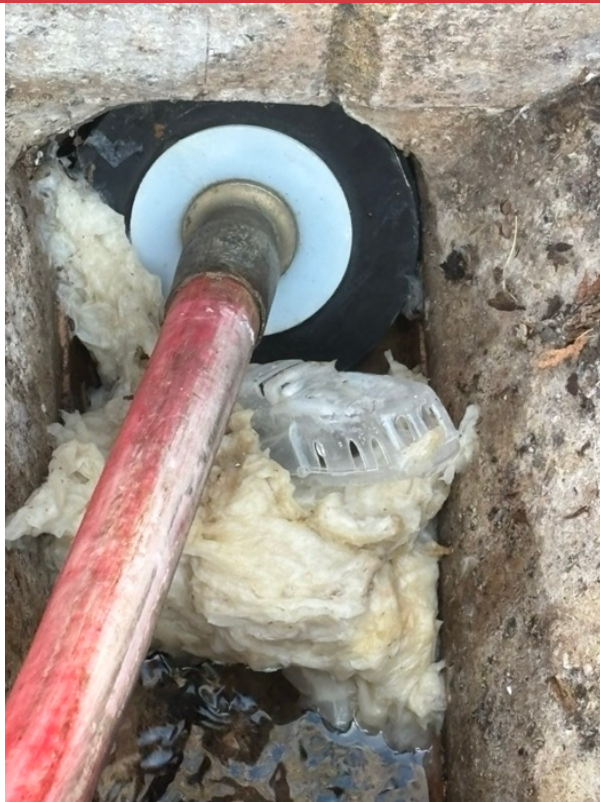
**15**

Assigned To Showing  
Original Obstruction During  
Removal  
Showing Original Obstruction  
During Removal

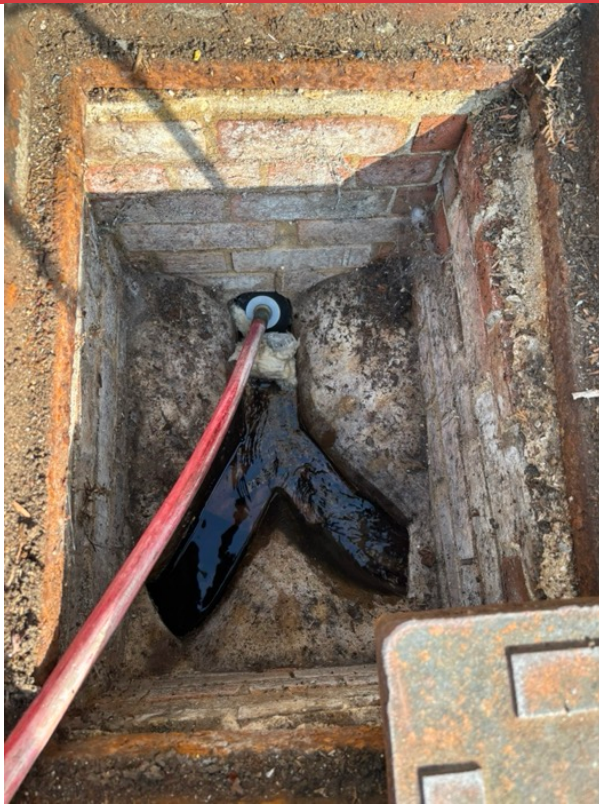
**16**

Showing Original Obstruction  
During Removal

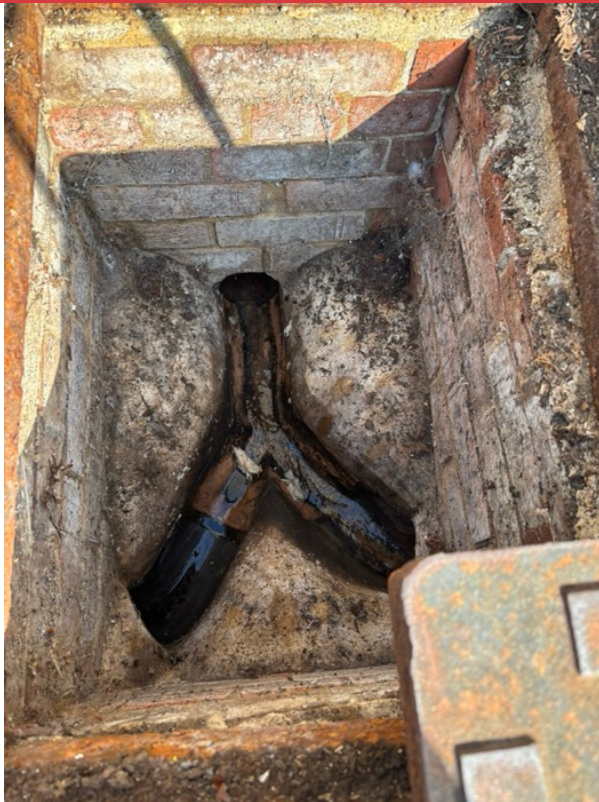
**17**

Flow Test After Blockage / Object  
Removal

Passed on flow test
