**PHIL'S DRAINAGE  
SERVICES LTD.**

Residential Property, Fleet

**Blocked main bathroom WC main 100mm diameter waste pipe**

**Thursday, 10 September 2026**

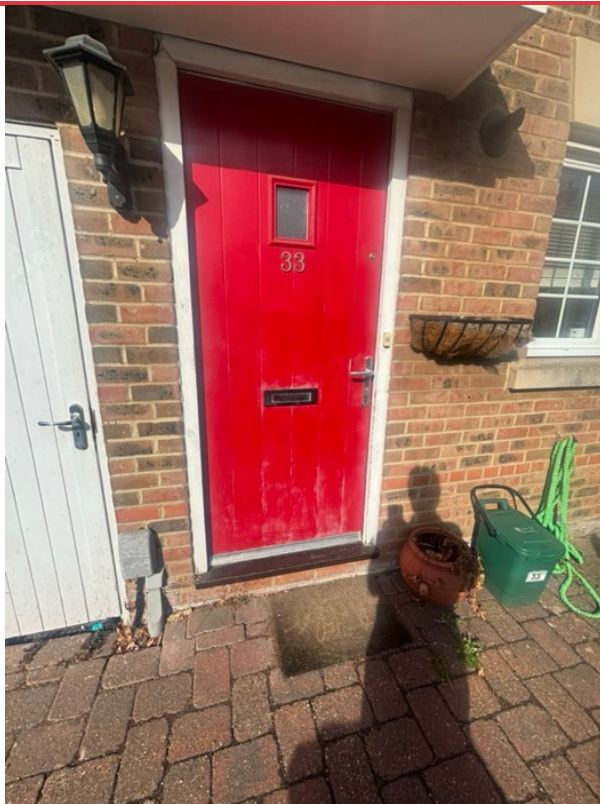
**1**

Attended The Premises

Due to a report of blocked foul water pipework within the main bathroom

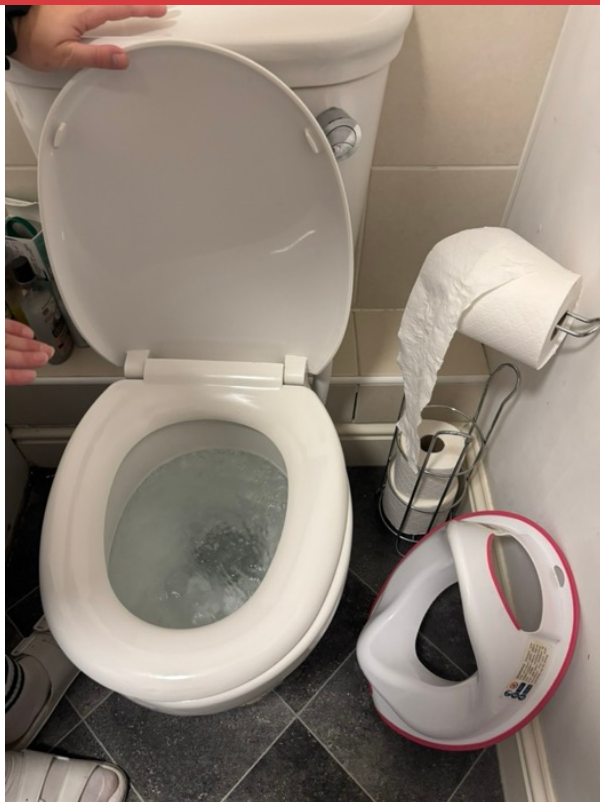
**2**

Upon Arrival We Located The Blocked WC

Within the upstairs main bathroom

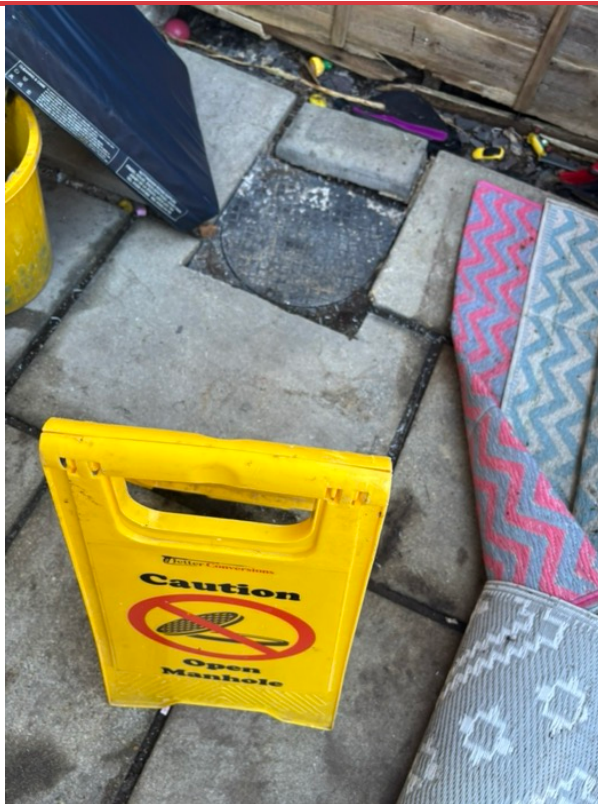
**3**

Assigned To Externally We Located The External Foul Water Chamber Externally We Located The External Foul Water Chamber within the rear garden (on the left )

And set up safety signage and barriers

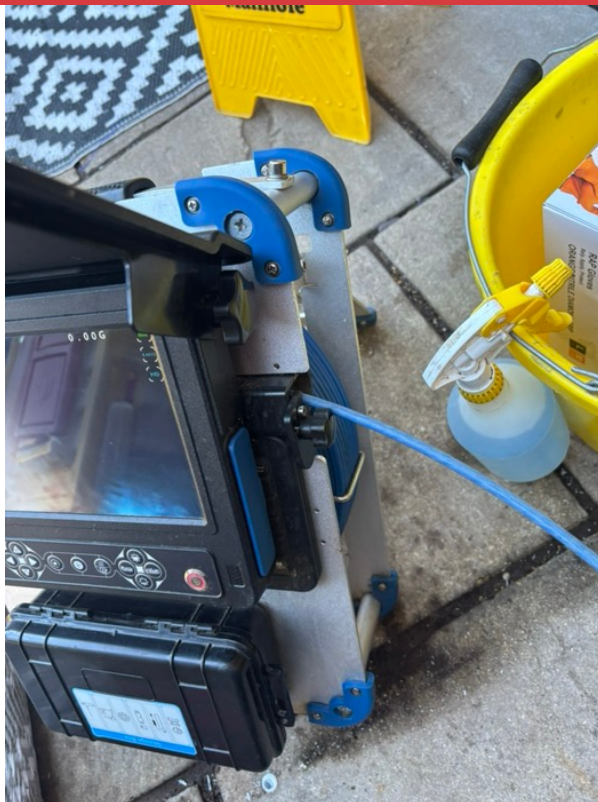
**4**

Made Direct Access Into The Chamber

Chamber clear we proceeded with using our small cctv drainage camera to locate the pipework blockage upstream towards the property

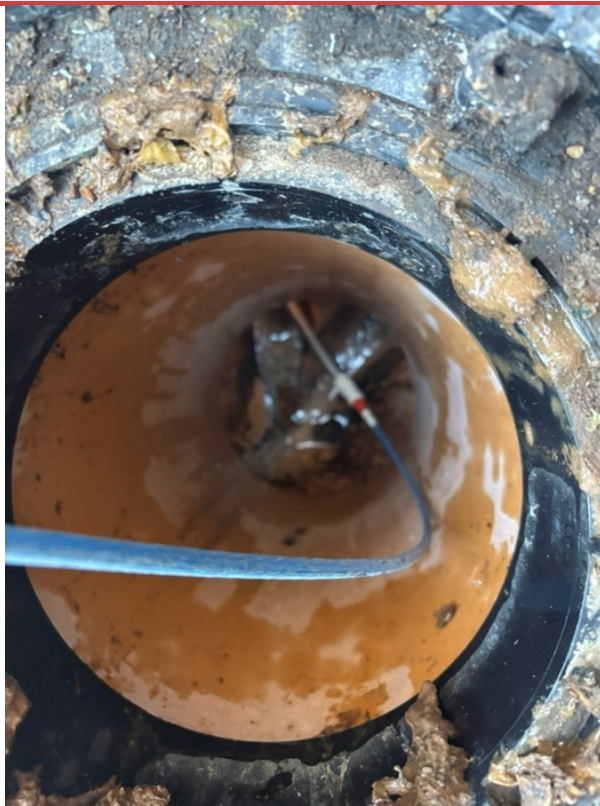
**5**

Showing camera head and direction

Upstream lateral 1 towards the main upstairs bathroom / WC  
100mm Upvc pipework

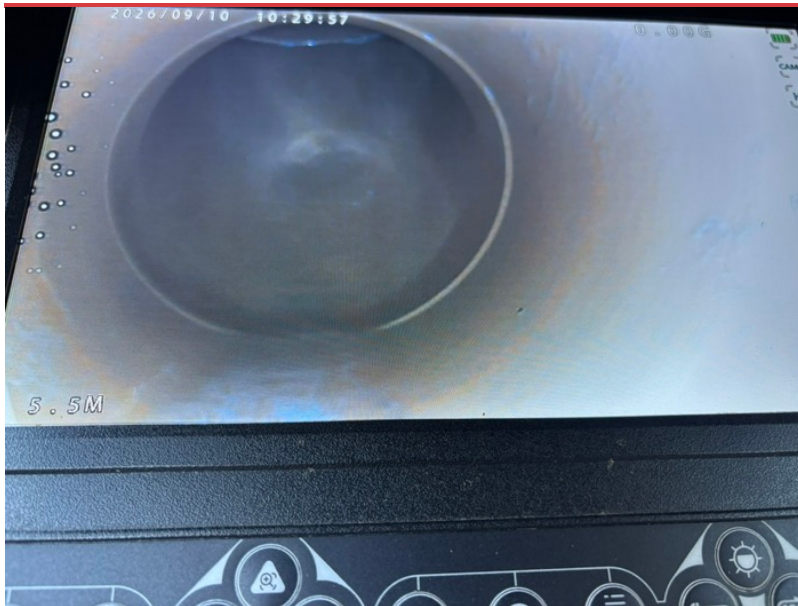
**6**

Camera arrived at internal rest bend bottom of the internal FW stack

Pipework clear

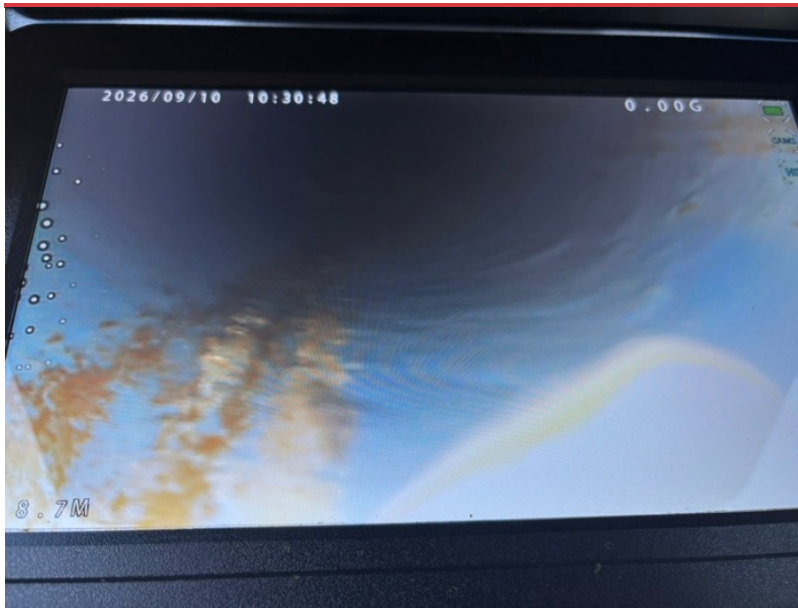
7

Camera arrived within the 100mm vertical FW stack Pipework

Attached scale deposits

The CCTV drainage camera was progressed upstream through the 100mm diameter UPVC foul-water pipework towards the main upstairs bathroom/WC and successfully reached the rest bend at the base of the internal foul-water stack. During the CCTV investigation, attached scale deposits were clearly identified within the internal 100mm diameter vertical foul-water stack. These deposits have accumulated against the internal bore of the pipework and are reducing the clean, unrestricted

Although the immediate blockage has been successfully removed and flow restored, the CCTV investigation has identified significant attached and settled scale deposits within the internal 100mm diameter WC float line and

the associated internal foul-water stack.

In our professional opinion, these remaining deposits present an increased risk of foul waste, toilet tissue and other discharged material catching and accumulating against the restricted/roughened internal pipe surface, which can contribute to common recurring blockages if left untreated.

Phil's Drainage Services Ltd therefore recommends that a methodical internal drainage descale and clean is undertaken.

The recommended works would utilise a combination of electromechanical cleaning (EMC) and high-pressure water jetting (HPWJ), with a CCTV drainage camera used in support throughout the cleaning process.

The purpose of these works would be to methodically break down, dislodge and remove as much of the attached and settled scale deposits as reasonably practicable from the internal 100mm diameter WC float line and internal foul-water stack, while using CCTV imagery to monitor progress and target areas of heavier accumulation.

Following the descale, the affected pipework should be thoroughly flushed through towards the external foul-water chamber, with loosened scale and debris captured and removed where practicable. A final CCTV inspection and flow test should then be undertaken to confirm the condition and performance of the cleaned pipework.

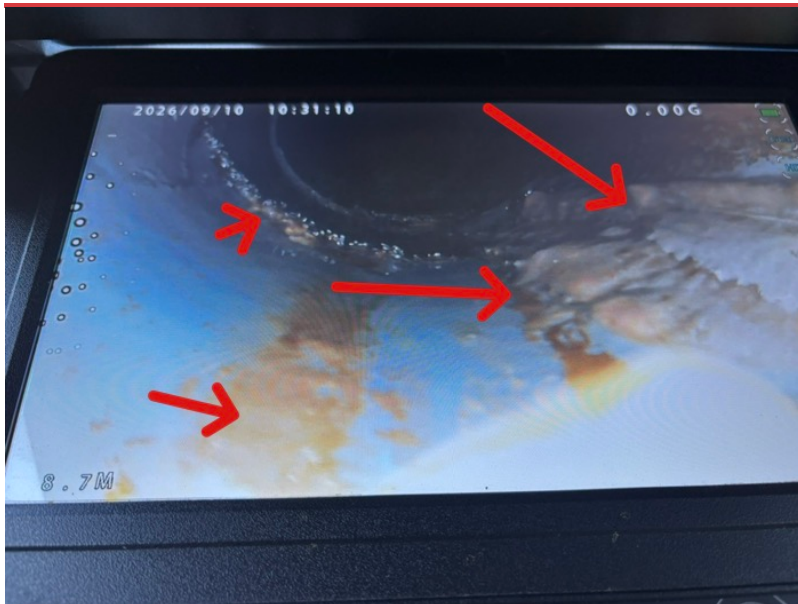
8

Camera arrived within the 100mm vertical FW stack Pipework

Attached scale deposits

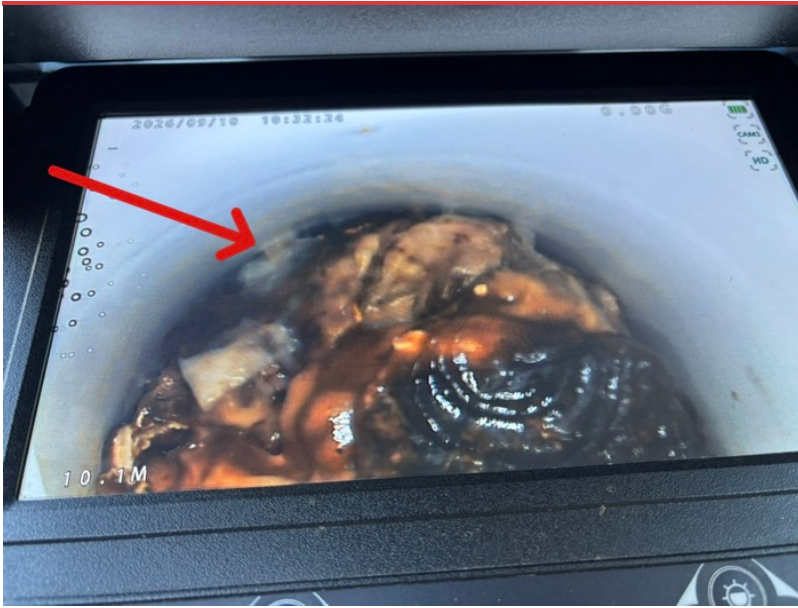
**9**

Blockage located within WC  
100mm diameter float line

Mass scale and soft tissue  
blockage

Further investigation identified the blockage within the 100mm diameter WC float line, consisting of a mass accumulation of scale and soft tissue material.

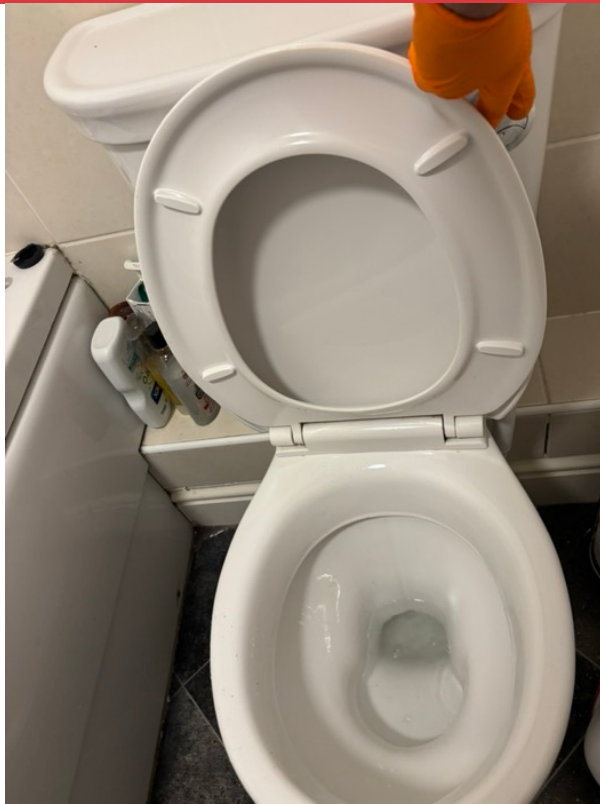
**13**

Multiple flow tests of all bathroom facilities being carried out

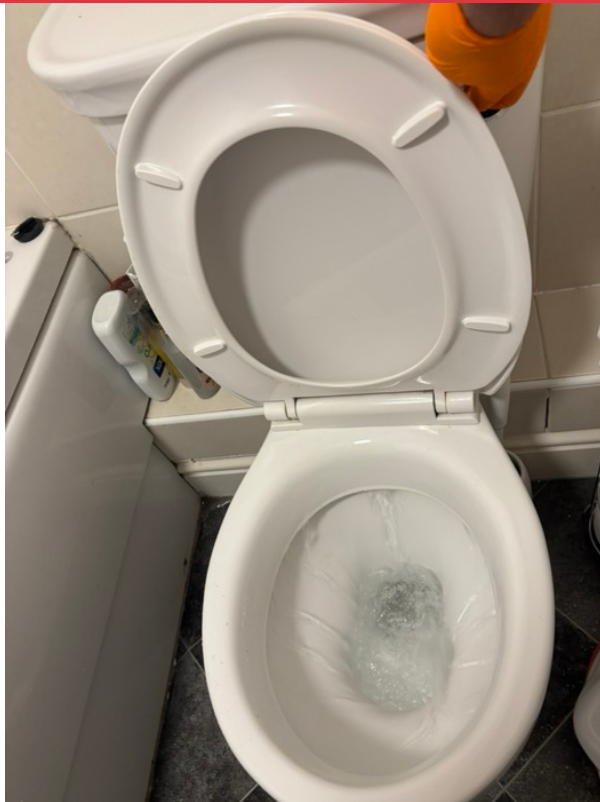
**14**

Multiple flow tests of all bathroom facilities being carried out

Flow test passed on test

Following clearance, multiple flow tests were undertaken using the bathroom facilities. At the time of attendance, the system passed the flow tests and was left operational and free-flowing.
