**PHIL'S DRAINAGE  
SERVICES LTD.**

Commercial Property, Fleet

**Blocked ground floor WC**

**Tuesday, 4 August 2026**

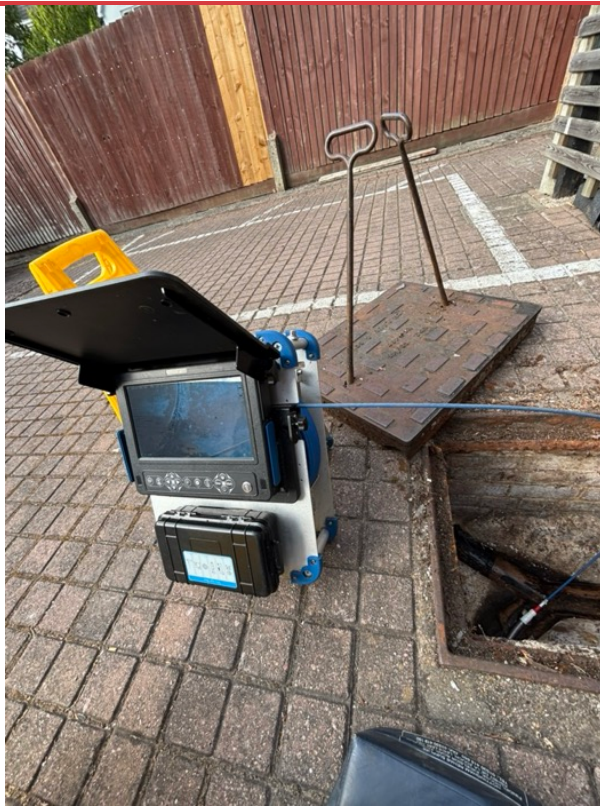
**5**

Assigned To Cctv Drainage  
Camera In Support

Direction external chamber  
upstream towards internal foul  
water stack (ground floor wc s )

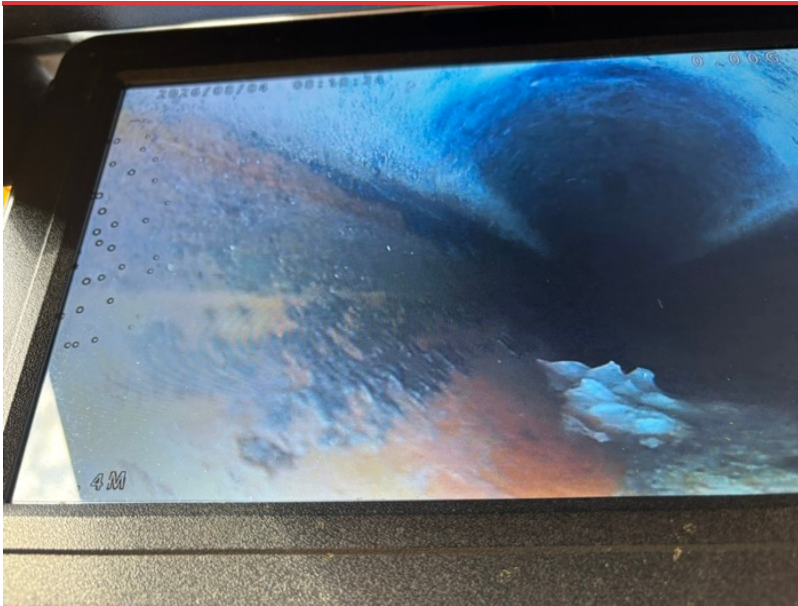
**6**

Assigned To Cctv Drainage  
Camera In Support

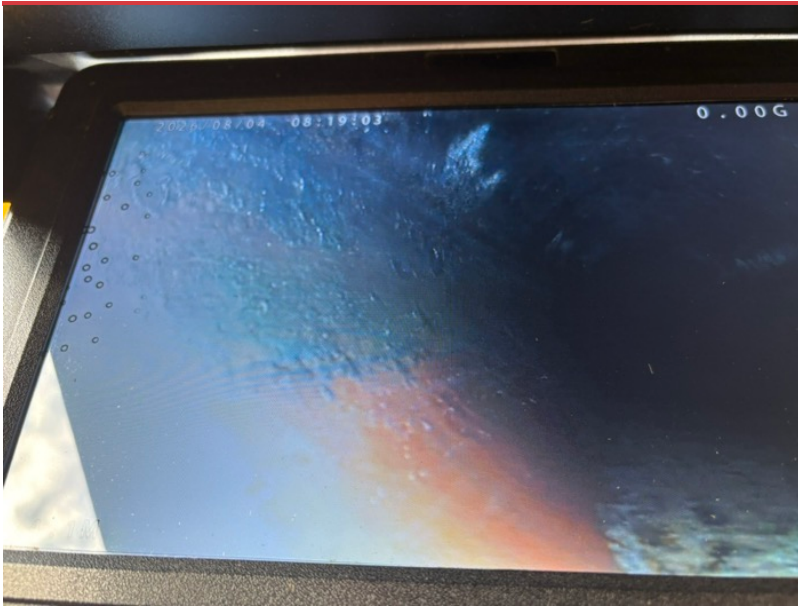
**7**

Assigned To Cctv Drainage  
Camera In Support Direction  
external chamber upstream  
towards internal foul water stack  
(ground floor wc s )

To accurately diagnose the cause of the blockage, a CCTV drainage survey was undertaken from the external inspection chamber upstream towards the internal 100mm foul water stack serving the ground floor WC facilities. The CCTV inspection identified extensive uric scale deposits attached to the internal walls of the vertical 100mm foul water stack

associated with the urinal discharge. These hard mineral deposits had significantly reduced the internal bore of the pipework and created a point where debris could accumulate. During the inspection, a plastic toilet freshener was also found lodged within the affected section of pipework, contributing to the restriction. Beyond this area, the remaining pipework was found to be free flowing.

A full descale using specialist electromechanical cleaning equipment with appropriate chain flails is recommended to remove the attached uric scale back to the original pipe wall wherever practicable, restoring the maximum internal bore and reducing the risk of future blockages.

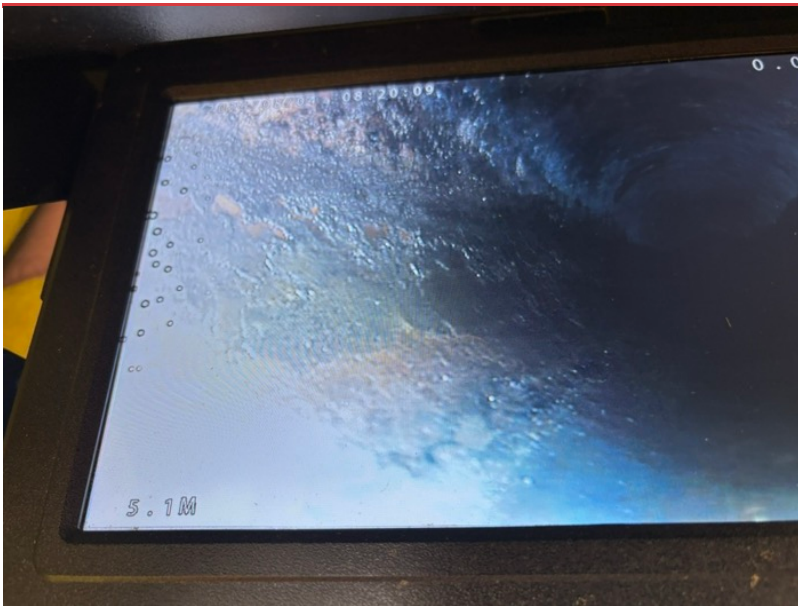
**8**

Assigned To Cctv Drainage  
Camera In Support Direction  
external chamber upstream  
towards internal foul water stack  
(ground floor wc s )
